# Manhole Inspection Summary

Manhole # S13UU1004MH

**Location** Address: **NORTHERN PKWY**

Cross Street: **BELVEDERE AVE**

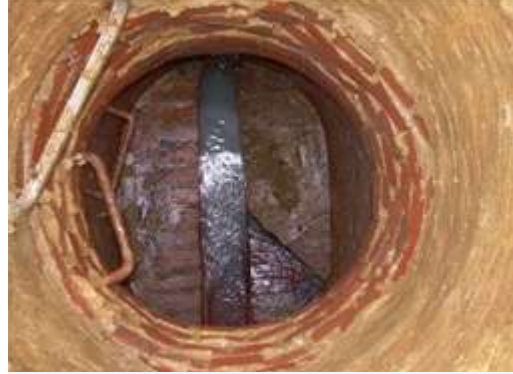
Top View

Evidence of surcharge - Bench debris.  
Corroded steps.

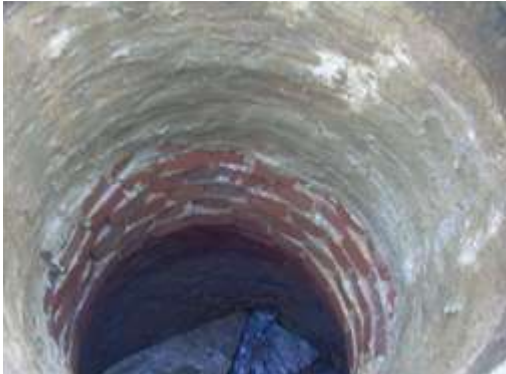
Defect

Frame leaks. Adjustment deterioration  
and infiltration. Corbel and Barrel  
infiltration.

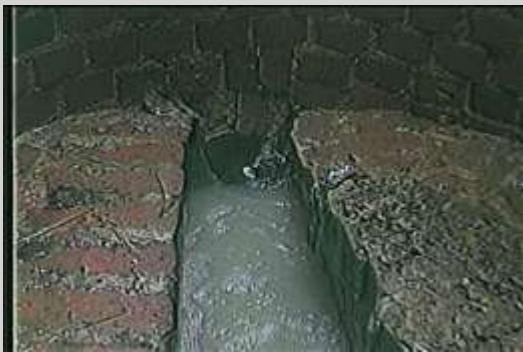
### 8 in. Circular Gravity Sewer Pipe Out @ 12 O'Clock

Barrel deterioration and infiltration.

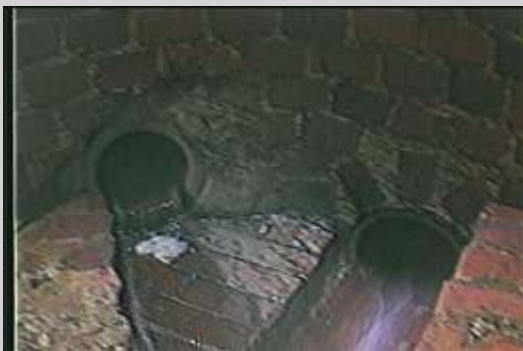
### 6 in. Circular Gravity Sewer Pipe In @ 5 O'Clock

Infiltration: **Evidence** Pipe Seal Cond: **Unknown**

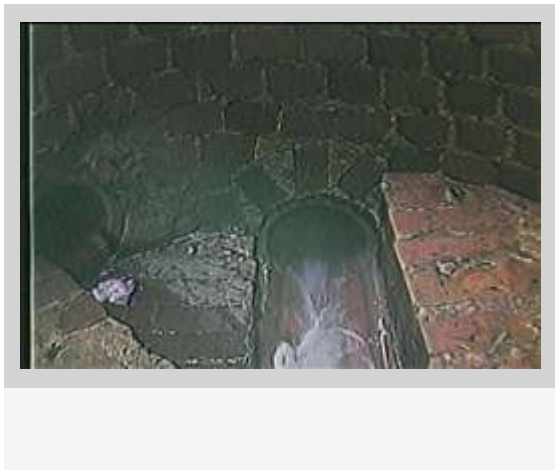
8 in. Circular Gravity Sewer  
Pipe In @ 6 O'Clock

Infiltration: **Evidence** Pipe Seal Cond: **Unknown**
